Appendix C

Sample Descriptions

This appendix provides a tabular and photographic summary of OU 7-13/14 samples taken during the OU 7-10 Glovebox Excavator Method Project at the SDA. Table C-1 lists in tabular format the summary sample description. The field description is summarized as described in the OU 7-13/14 Field Representative GEM Logbook-Glovebox Book (Olson 2004a). The lab description is a summary of the visual observations made while photographing the samples. The appearance category is the synopsis of all three descriptions made by the authors. Field categories are reported as recorded in the OU 7-13/14 Field Representative GEM Logbook (Olson 2004). The accuracy of the categorization is dependent upon the field representative and their interpretation.

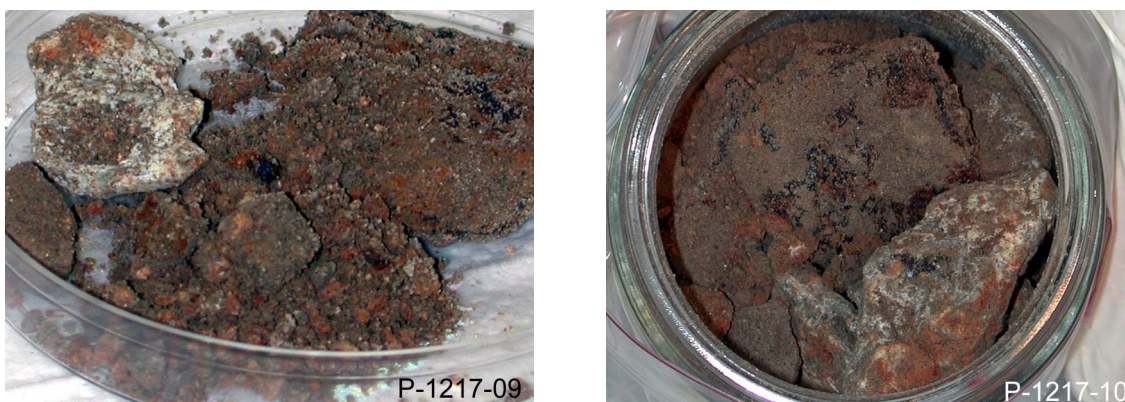
Figure C-5. A photographic image of sample P9GP05015G in a dish (left) in a jar (right).

The drum orientation appeared random with approximately 11 drum ring parts exposed. The waste characteristics were documented as mostly soil with bag and drum pieces uncovered. The debris constituted less than 10% of the content. There were no distinguishing container markings. The drum integrity was recorded as limited integrity, only pieces. The integrity of the bag was listed as good. Very little moisture existed on the sample. The soil was stained.

The field characterization identified the sample as an inorganic sludge. However, the photographic description may question the field characterization. Rather, the sample appeared as chunks of cement and white solid rock. Small pieces of rust colored sample were present and defined as soil pieces mixed with drum rust. Other than the drum rust, there were no characteristics that qualify this sample as a Series 741 inorganic sludge as described in Course Number 300GM028, “Waste Identification, Excavation, Segregation/Sorting, and Disposition.”

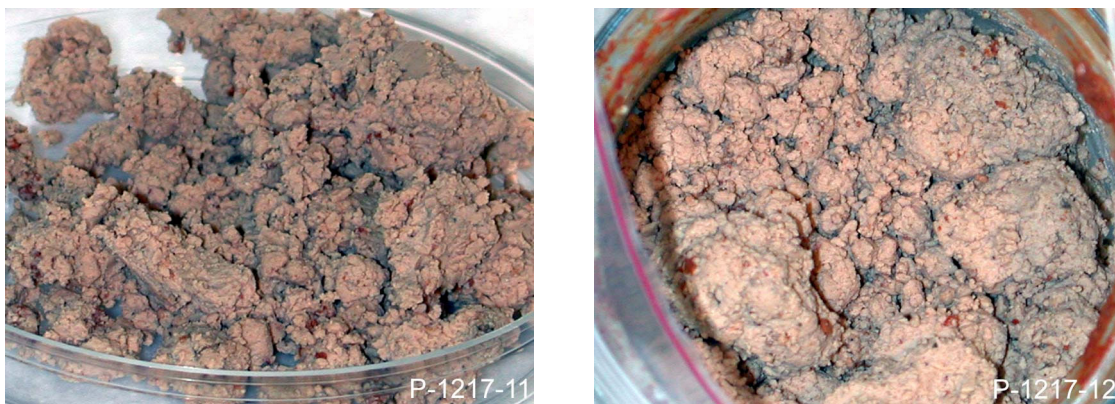
Figure C-6. A photographic image of sample P9GR04012G in a dish (left) in a jar (right).

During the excavation retrieval process, the drum liner containing the sludge was initially intact and pliable. The organic materials originally present in the sludge appeared to be retained due to the intact and pliable drum liner. As the excavator arm acquired the scoop of material, the liner broke due to shear forces. Much of the sludge remained in the scoop.

As noted in the OU 7-13/14 field representative logbook, the waste drum was located at an approximate depth of 14.47-ft and was severely corroded; however, the liner was intact until contact with the backhoe bucket. The drum did not have any visible or legible container markings. The scoop was retrieved from the right half center section of the active waste zone.

The sample was light tan in appearance. The color code description was given as Moderate Yellow 5Y 7/6 with Moderate Reddish Brown 10R 4/6 (Geological Society of America 1991) spots intermittently dispersed throughout. Photograph P-1217-11 above (Figure C-6) is the sludge sample removed from the original 250 mL jar (P-1217-12) and placed via clean spatula into a Petri sampling dish. The sample consistency resembled that of clumped peanut butter.

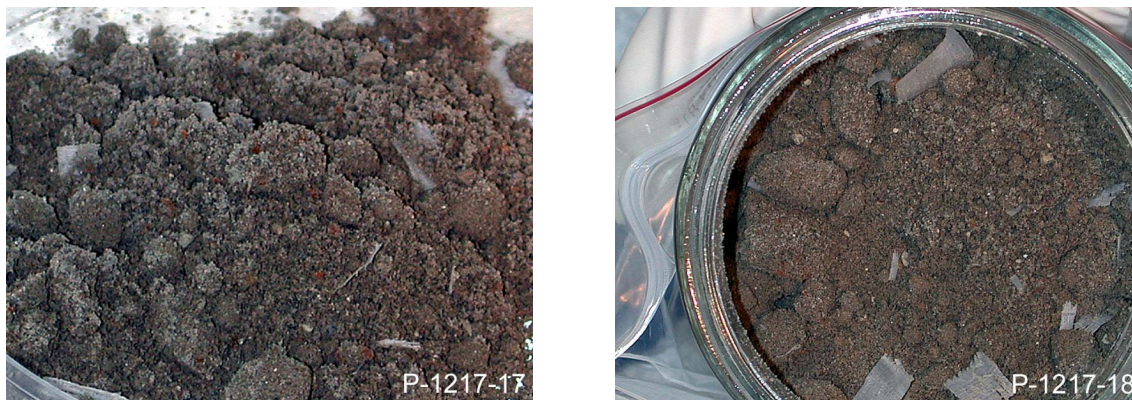
Figure C-9. A photographic image of sample P9GT01016G in a dish (left) in a jar (right).

Waste material was loose and not confined to a drum. There were no drum markings as all but the rings were corroded.

Sample P9GT01016G appears to be primarily soil with small pieces of white cloth and some rust present.

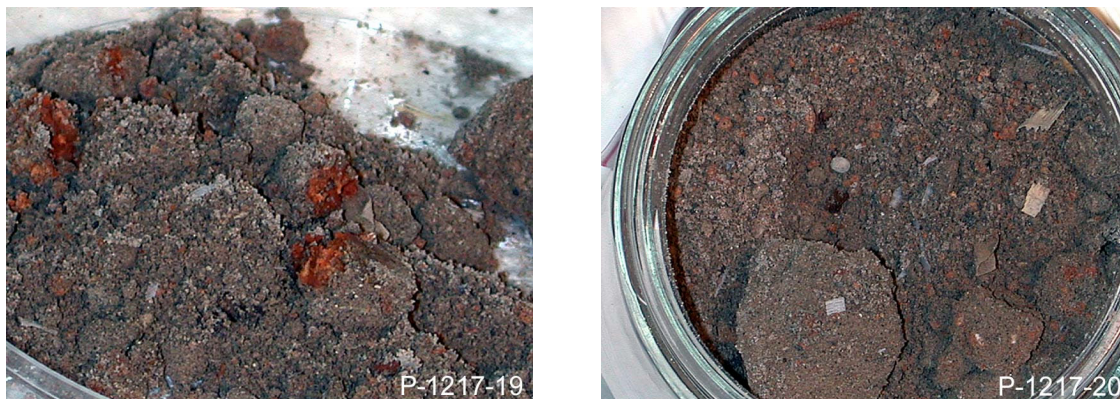
Figure C-10. A photographic image of sample P9GT02016G in a dish (left) in a jar (right).

The field characterization defined the sample as interstitial soil. The sample visually consisted of greater than 90% soil with small pieces of white cloth and some rust particles present. Red materials shown in Figure 12 are apparent drum rust.

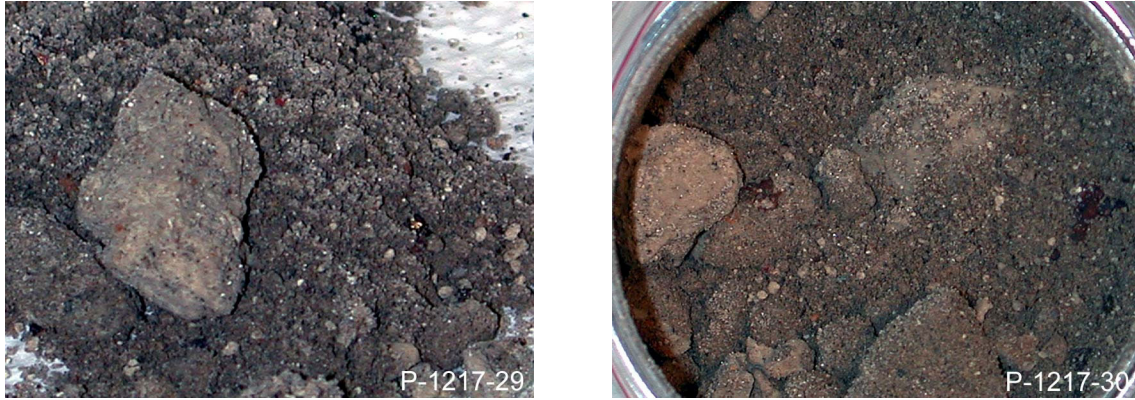
Figure C-14. A photographic image of sample P9GT06016G in a dish (left) in a jar (right).
